# Manhole Inspection Summary

Manhole # S39Y1\_036MH

**Location** Address: **3601 5th St.**

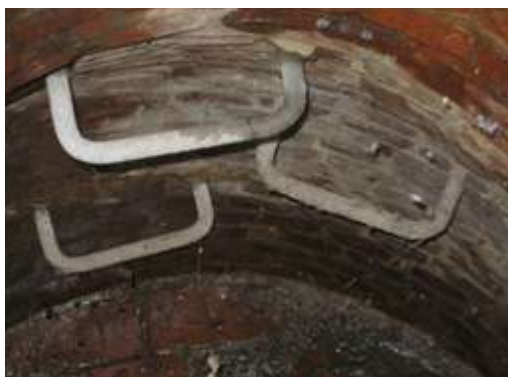
**Steps** Count: **3** Missing: **0** ☒ **Corroded**

Steps

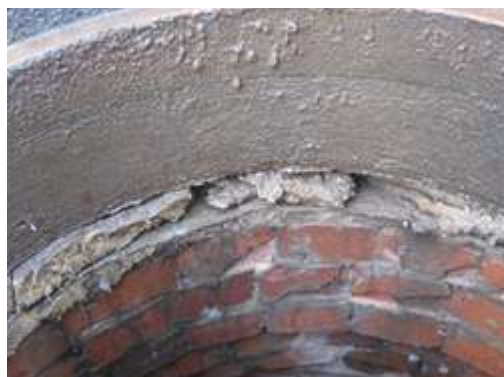
Defect 2

Condition: ☐ Sound ☒ **Cracked** ☐ Root Intrusion ☐ Loose Brick ☐ Deteriorated

Infiltration: ☐ None ☒ **Joint** ☒ **Cracks** ☐ Mortar ☐ Roots ☐ Wall

Chimney (Cracked)

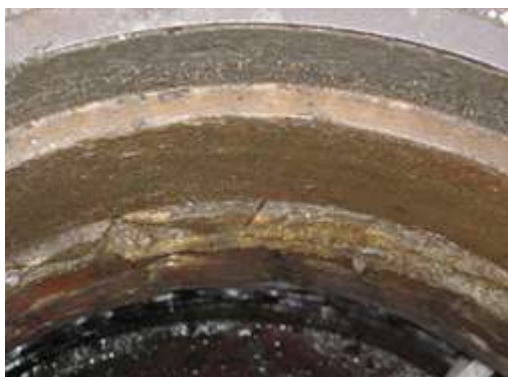
Defect 1

**Frame** Offset: **1** (in.) Condition: ☒ Sound ☐ Cracked ☐ Leaks

Frame Offset

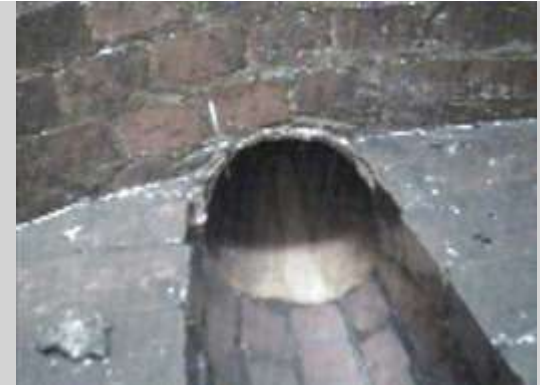
12 O'Clock Outflow

8 in. Circular Gravity Sewer  
Pipe Out @ 12 O'Clock

Pipe Height: **8.4** (in.) Rod and Bar (Angled)  
Pipe Material: **Clay** ☐ Pipe Lined  
Invert Depth: **7.84** (ft.) Flow Characteristics: **None**  
Deposits: ☒ None ☐ Mud ☐ Sludge ☐ Debris ☐ Grease  
Silt Depth: (in.) Deposits Extent:  
Infiltration: **None** Pipe Seal Cond: **Cracked**

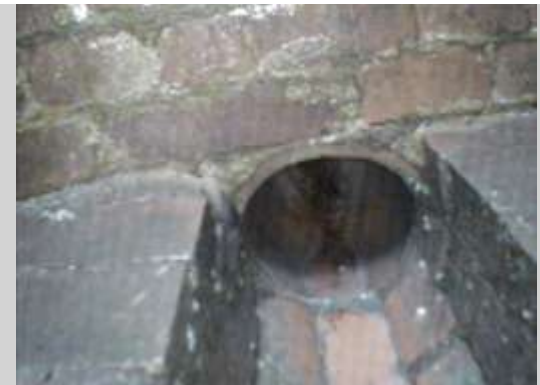
6 O'Clock Inflow

8 in. Circular Gravity Sewer  
Pipe In @ 6 O'Clock

Pipe Height: **6** (in.) Rod and Bar (Angled)  
Pipe Material: **Clay** ☐ Pipe Lined  
Invert Depth: **7.42** (ft.) Flow Characteristics: **None**  
Deposits: ☒ None ☐ Mud ☐ Sludge ☐ Debris ☐ Grease  
Silt Depth: (in.) Deposits Extent:  
Infiltration: **None** Pipe Seal Cond: **Sound**
